TECHNICAL REPORT H-77-22

BREAKWATER STABILITY STUDY IMPERIAL BEACH, CALIFORNIA

Hydraulic Model Investigation

Prepared for U. S. Army Engineer District, Los Angeles
Los Angeles, California 90053

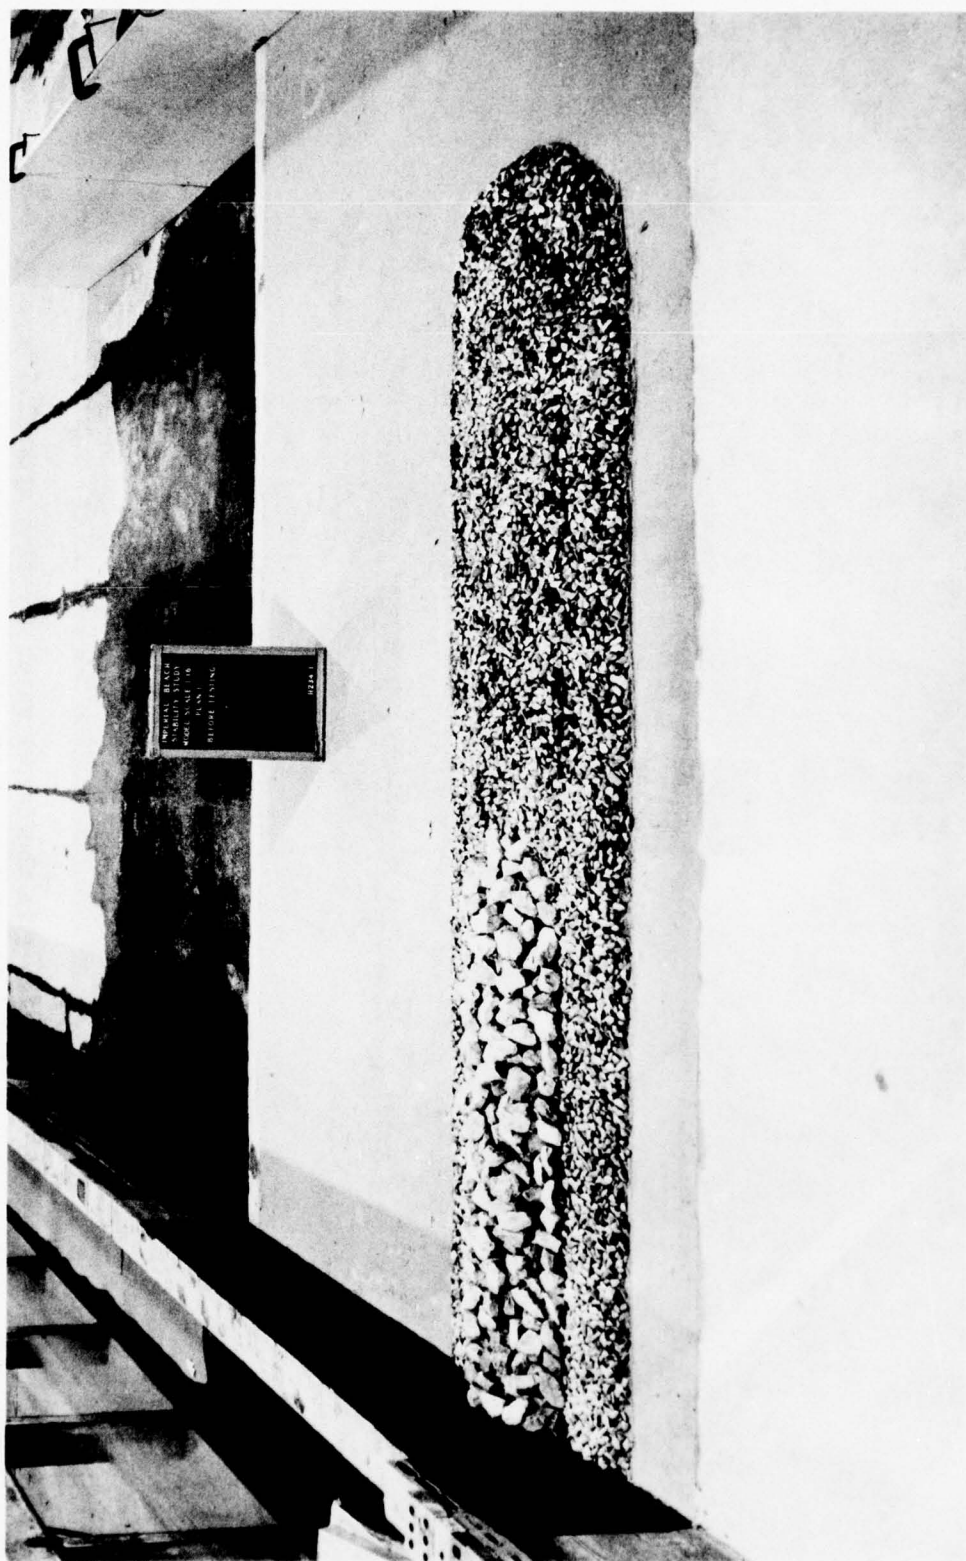
Photo 1. Sea-side view of Plan 1 before wave attack

12. Plan 1 (Plate 1 and Photo 1) was constructed in the deeper water location to high-sill and low-sill elevations of +0.4 and -5.0 ft mllw, respectively. The high sill was armored with 3.0-ton stone and the low sill used 300-lb stone. Armor slopes of 1V on 1.5H were used on both the sea side and beach side. Attack of 14.0-sec, 8.3-ft waves at an swl of 0.0 ft mllw for 1.5 hr produced moderate damage to both the low- and high-sill sections of the breakwater (Photo 2). Test conditions were changed to 14.0-sec, 12.1-ft waves at an swl of +5.4 ft mllw, and 2.0 hr of wave attack produced extensive damage to all portions of the breakwater (Photo 3).

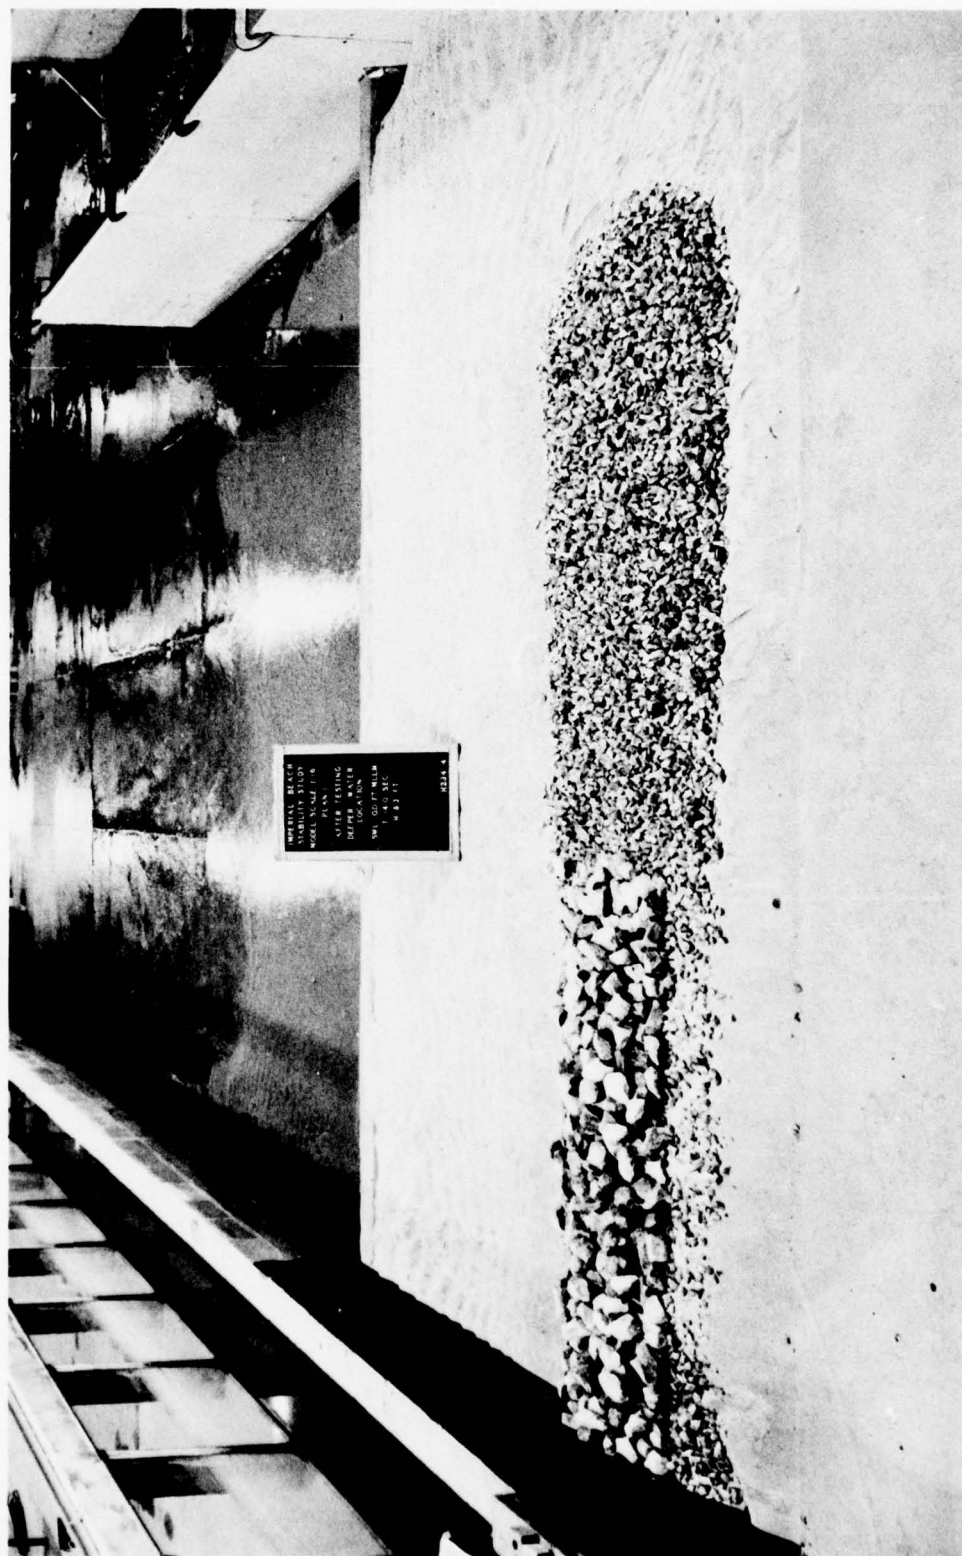
Photo 2. Sea-side view of Plan 1 in the deeper water location after 1.5 hr of 14.0-sec, 8.3-ft waves at an swl of 0.0 ft mllw

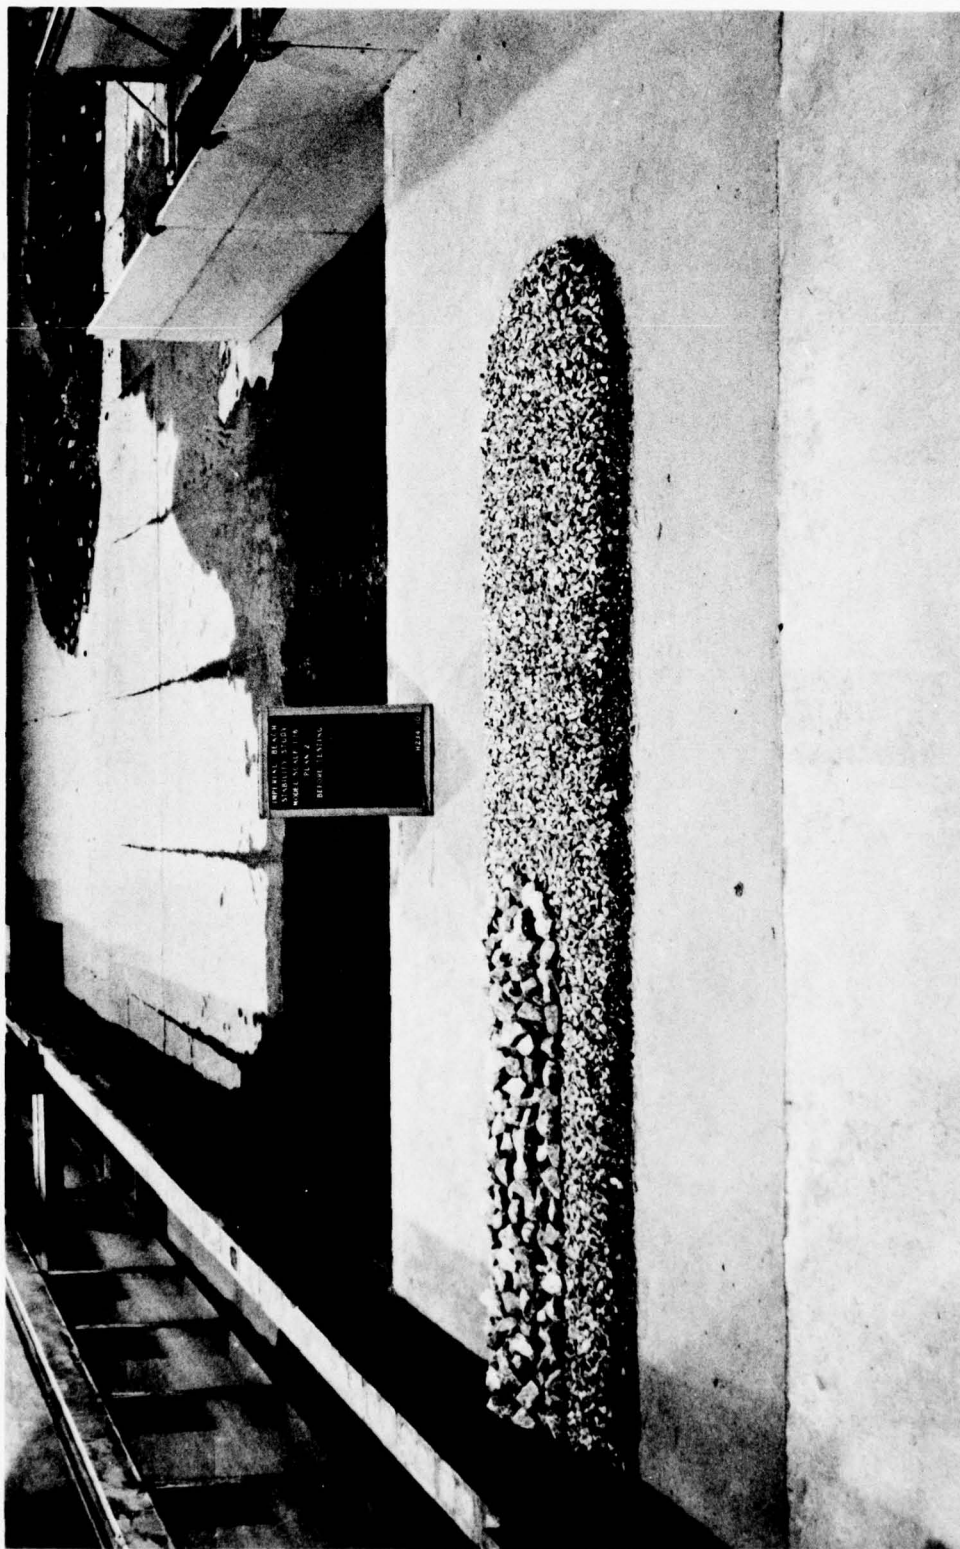
Photo 4. Sea-side view of Plan 2 before wave attack

13. Plan 2 (Plate 2 and Photo 4) was similar to Plan 1 except a 2.0-ft-thick blanket of 25-lb filter material was added to the bottom of the structure. Crown elevations of +2.4 and -5.2 ft mllw were used for the deeper water location. Attack of 14.0-sec, 8.3-ft waves at an swl of 0.0 ft mllw for 1.5 hr produced moderate damage to both the low- and high-sill sections of the breakwater (Photo 5). Attack of 14.0-sec, 12.1-ft waves at an swl of +5.4 ft mllw for 1.0 hr produced extensive damage to all portions of the breakwater (Photo 6).

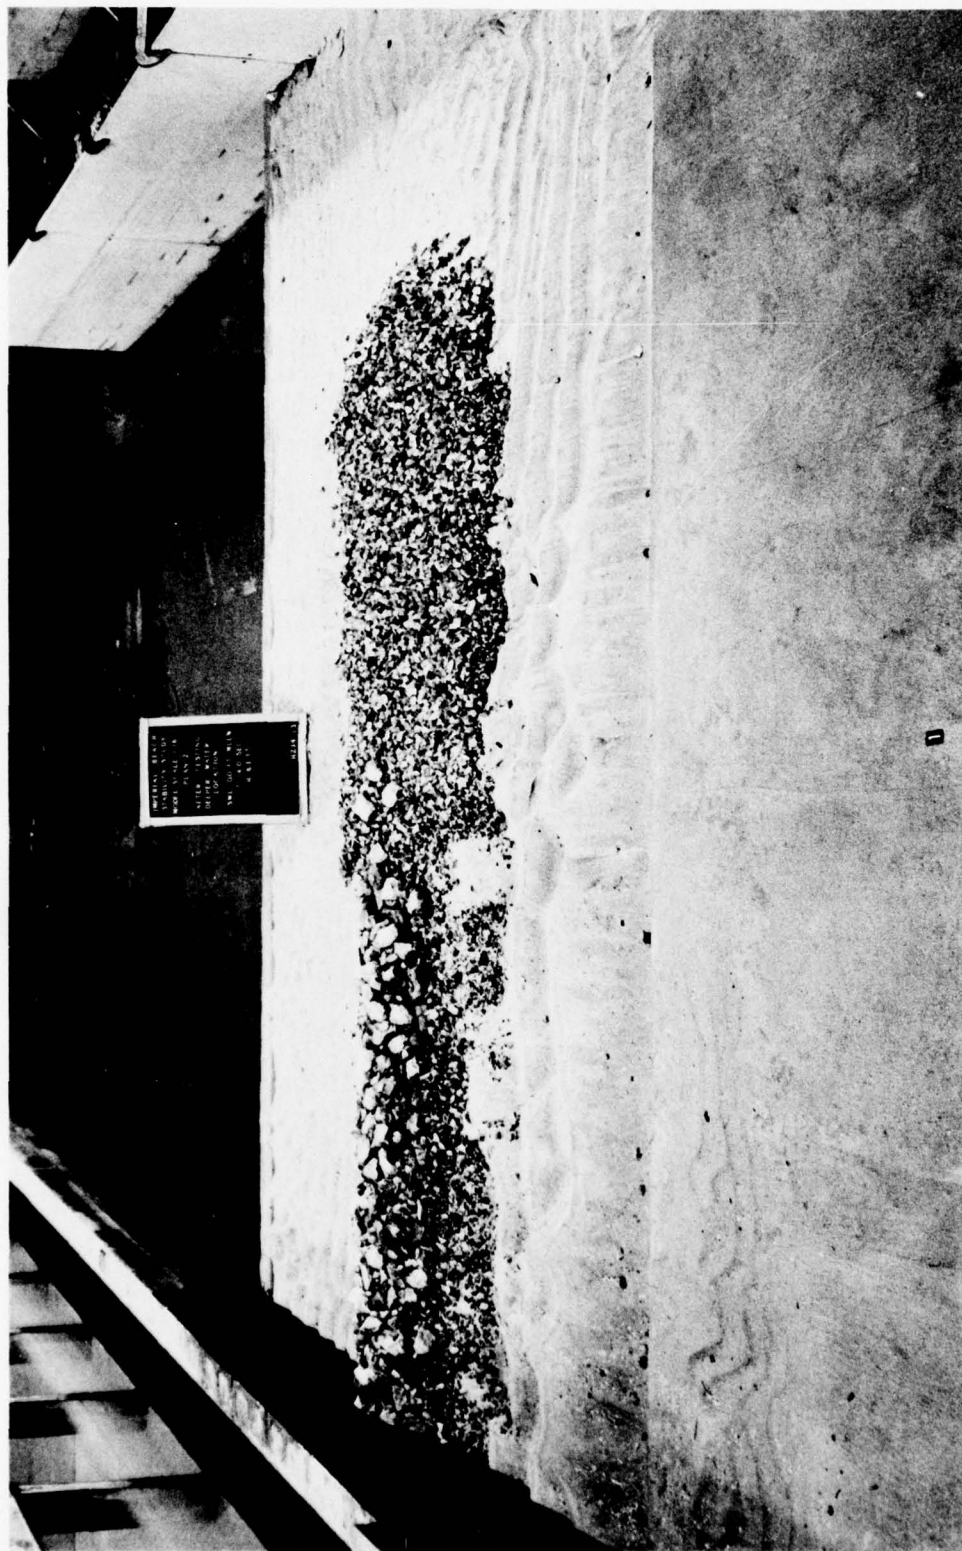
Photo 5. Sea-side view of Plan 2 in the deeper water location after 1.5 hr of 14.0-sec, 8.3-ft waves at an swl of 0.0 ft mllw

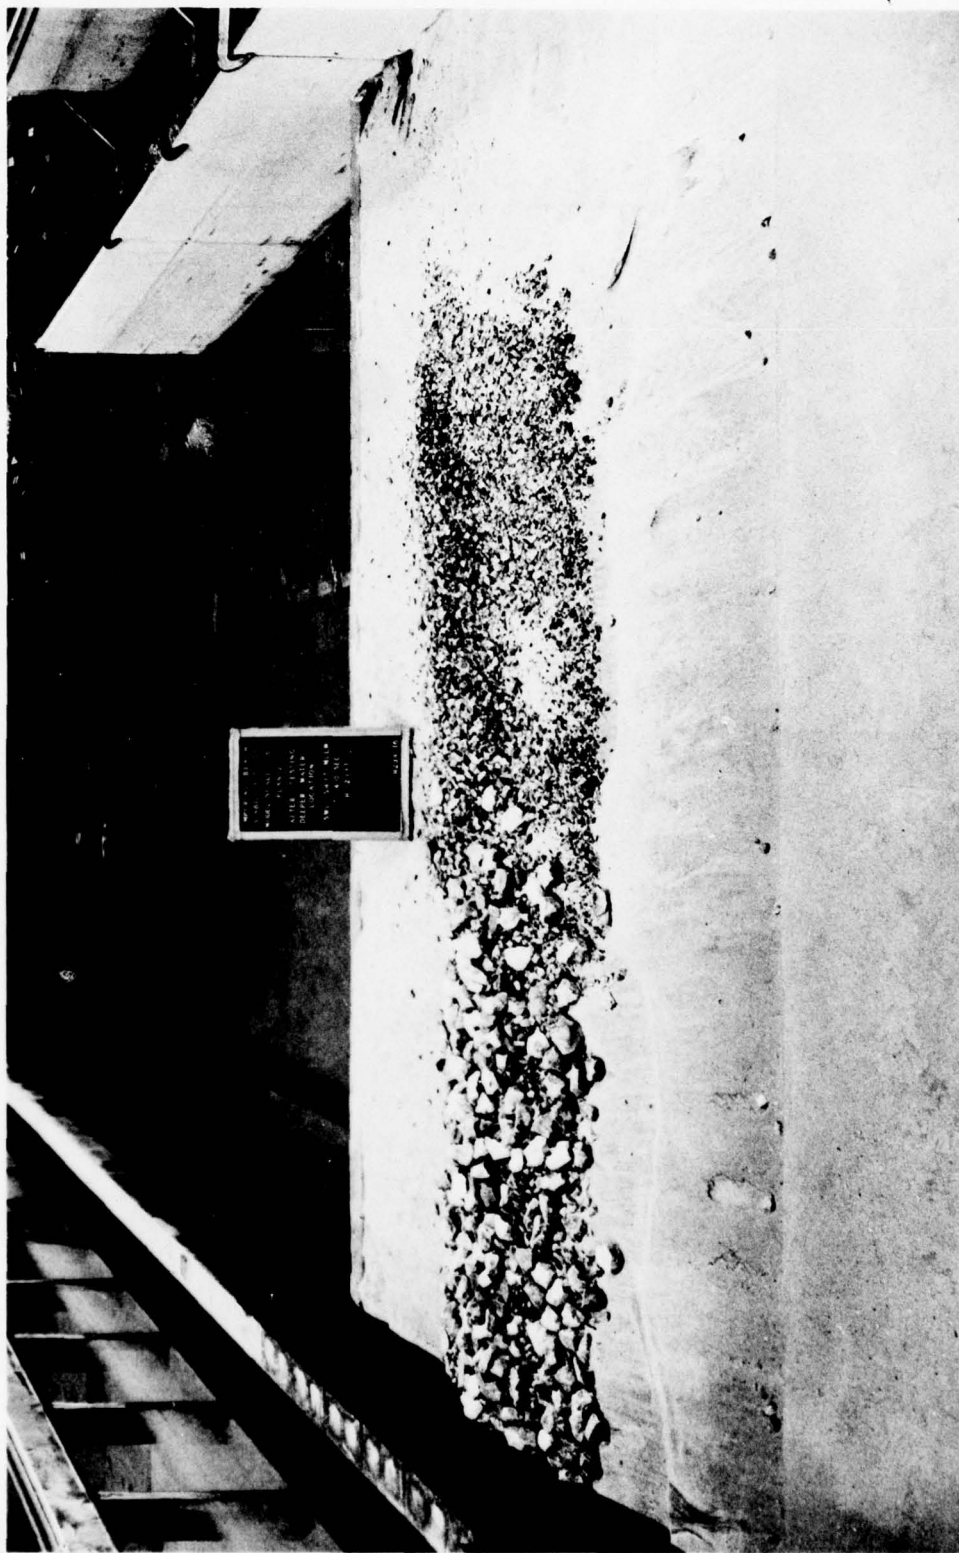
Photo 6. Sea-side view of Plan 2 in the deeper water location after 1.0 hr of 14.0-sec, 12.1-ft waves at an swl of +5.4 ft mllw

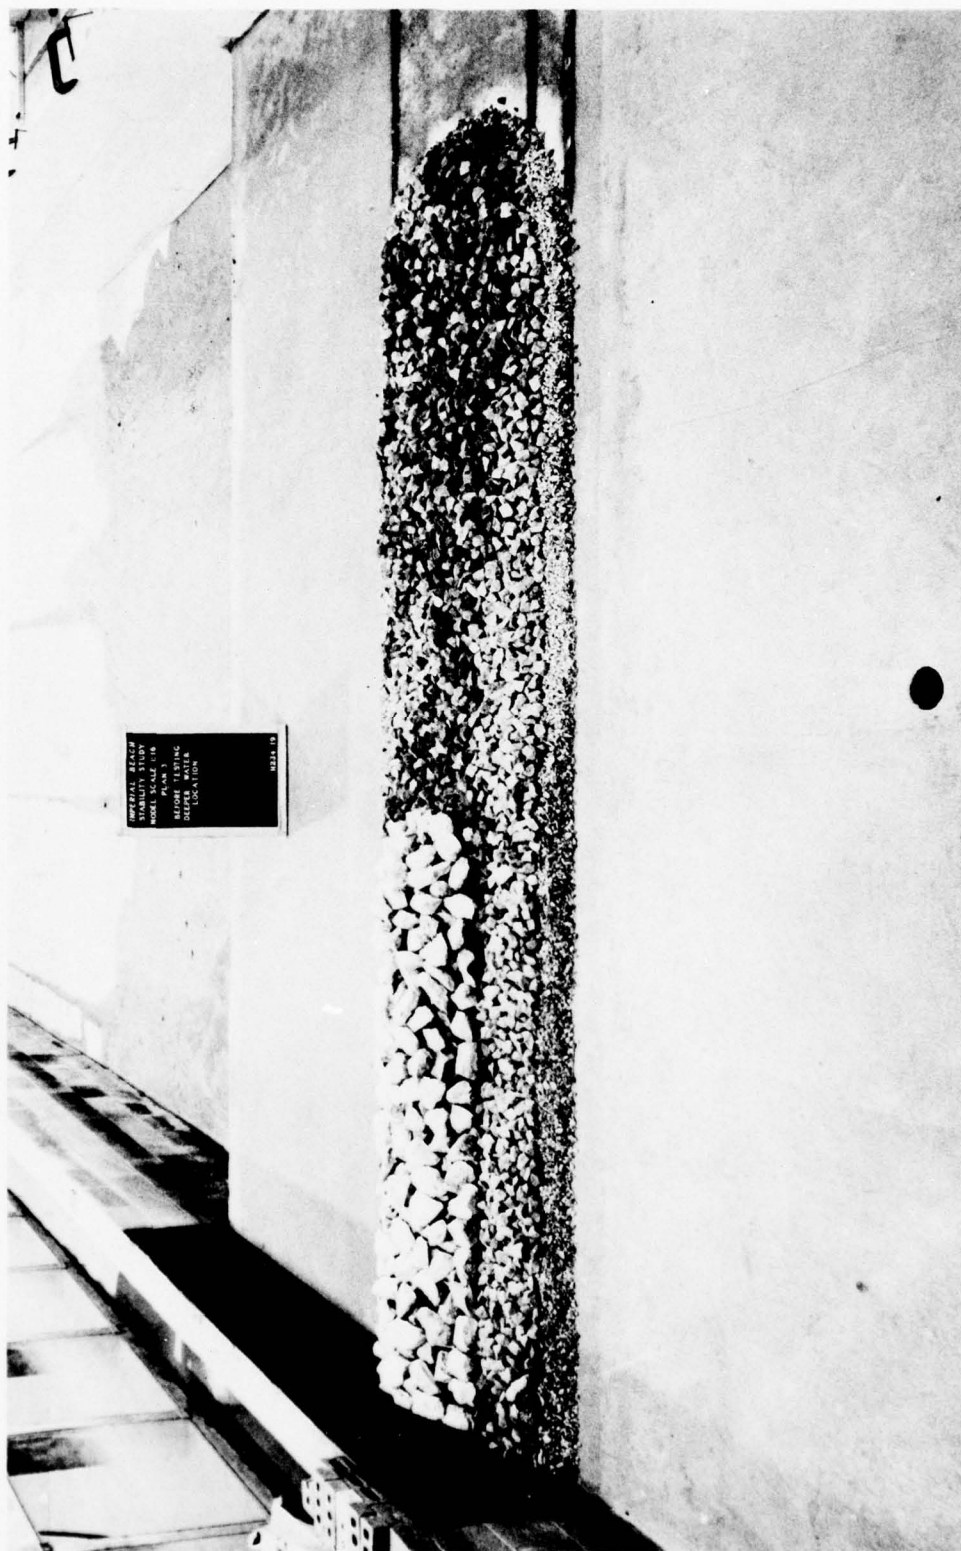
Photo 7. Sea-side view of Plan 3 before wave attack

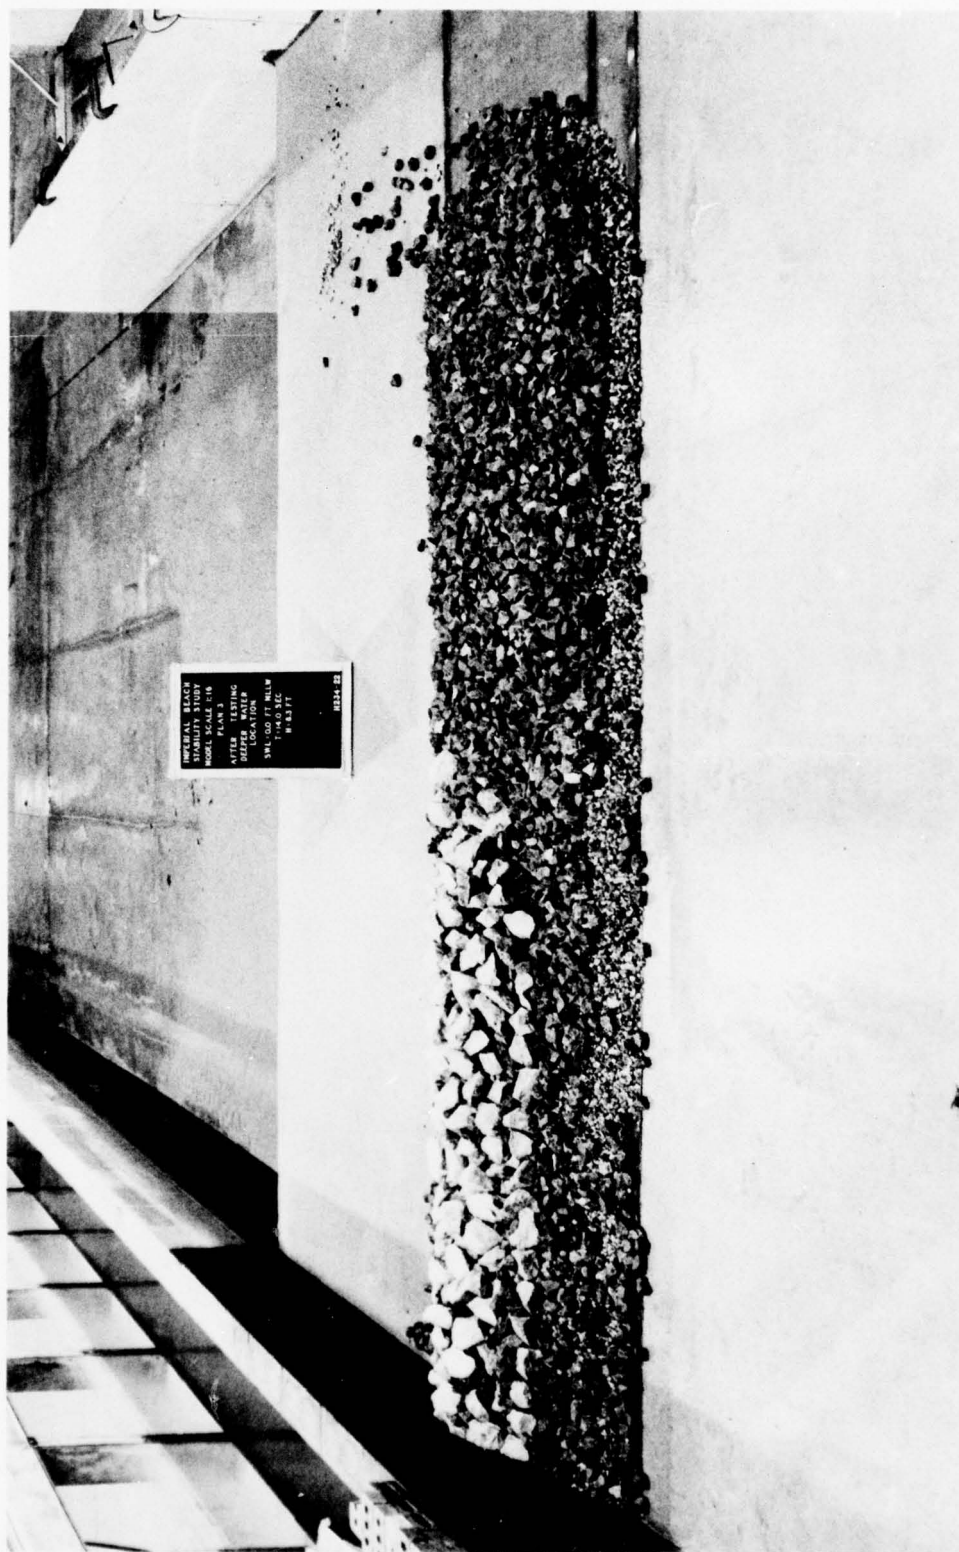
Photo 8. Sea-side view of Plan 3 in the deeper water location after 2.0 hr of 14.0-sec, 8.3-ft waves at an swl of 0.0 ft mllw

elevation of -3.8 ft mllw in the deeper water location (equivalent to +1.2 ft mllw in the shallow-water location). Testing in the deeper water location with 14.0-sec, 8.3-ft waves at an swl of 0.0 ft mllw for 2.0 hr produced only minor damage (Photo 8); however, 2.0 hr of attack by 14.0-sec, 12.1-ft waves at an swl of +5.4 ft mllw produced extensive damage (Photo 9). The breakwater was rebuilt in the shallow-water location and 2.0 hr of 14.0-sec, 4.5-ft waves at an swl of 0.0 ft mllw and 2.0 hr of 14.0-sec, 8.5-ft waves at an swl of -5.4 ft mllw produced only minor damage (Photos 10-13).

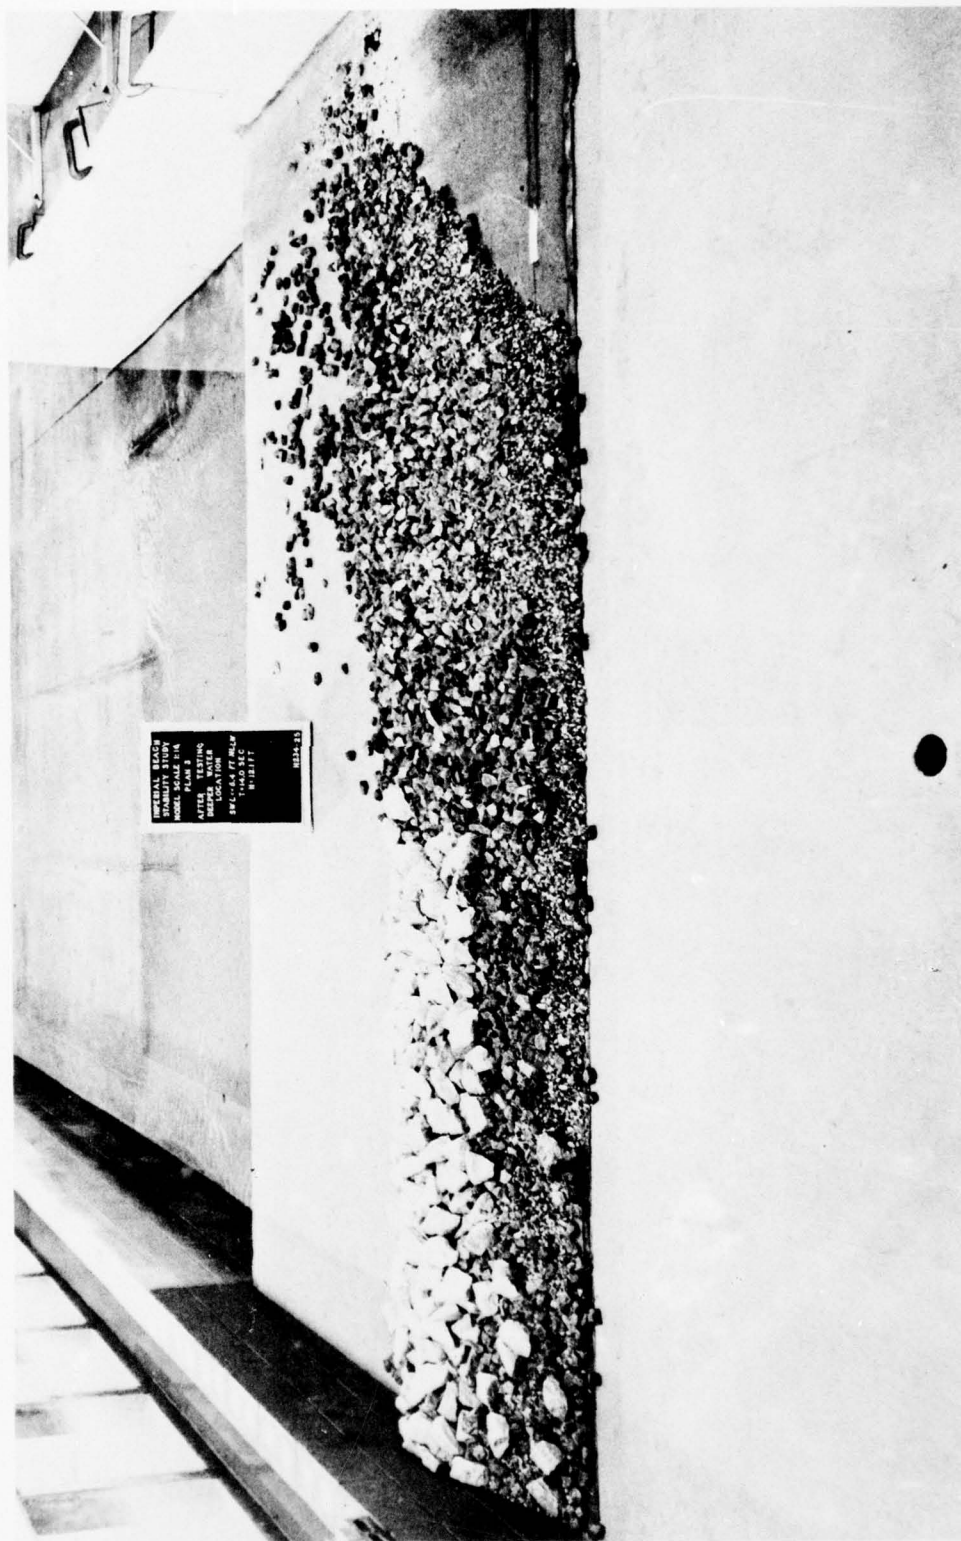
Photo 9. Sea-side view of Plan 3 in the deeper water location after 2.0 hr of 14.0-sec, 12.1-ft waves at an swl of +5.4 ft mllw

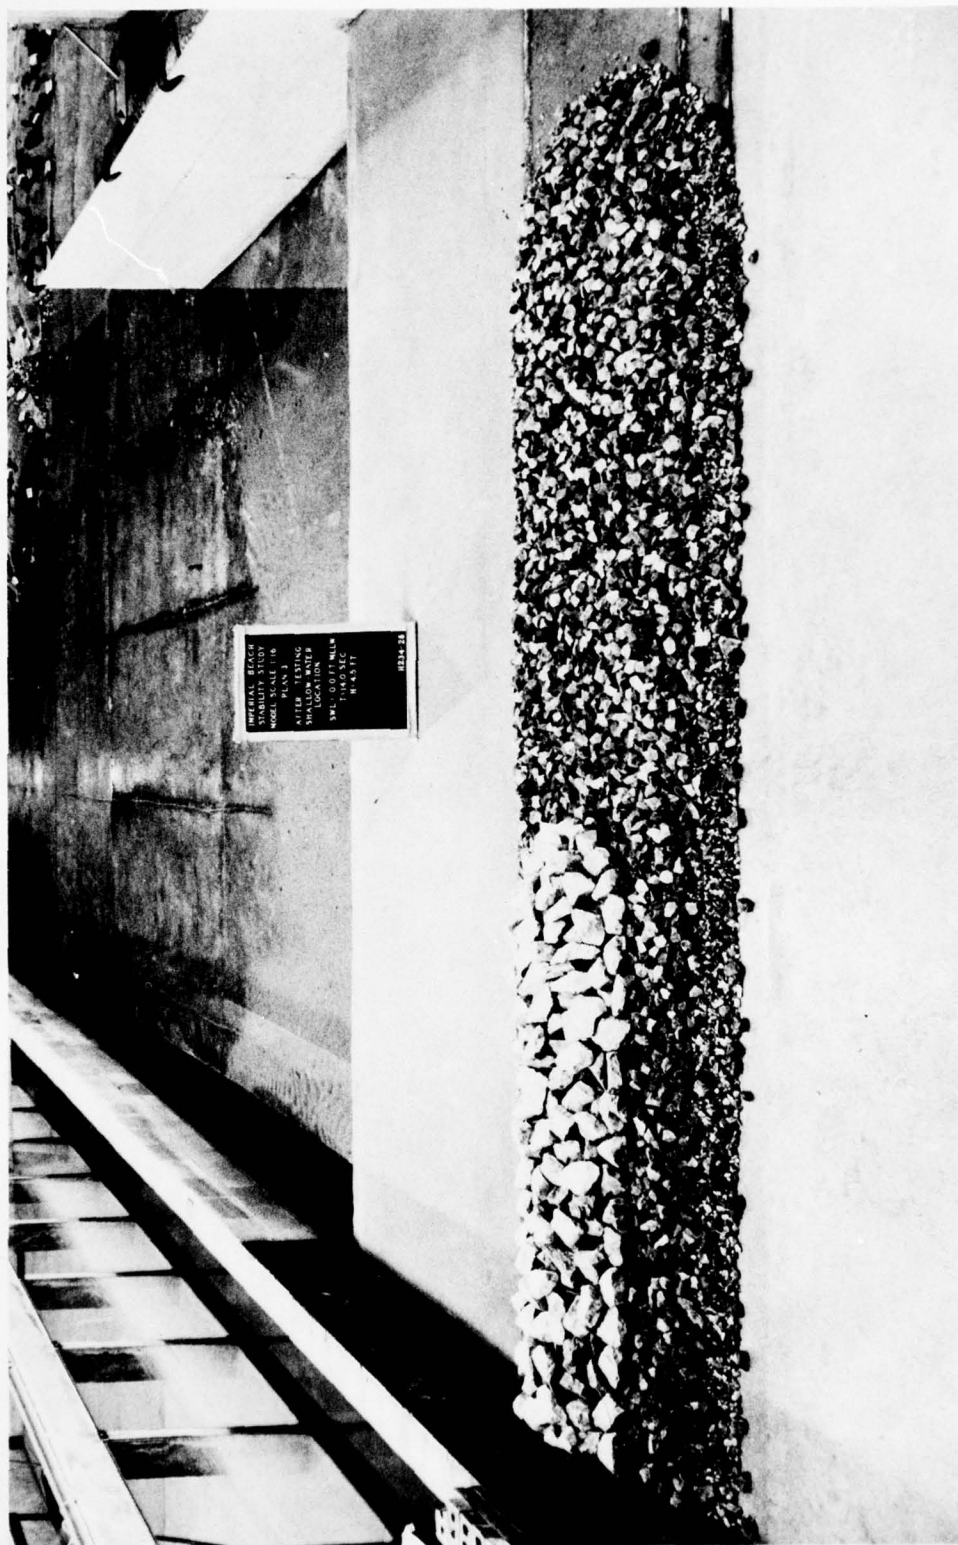
Photo 10. Sea-side view of Plan 3 in the shallow-water location after 2.0 hr of 14.0-sec, 4.5-ft waves at an swl of 0.0 ft mllw

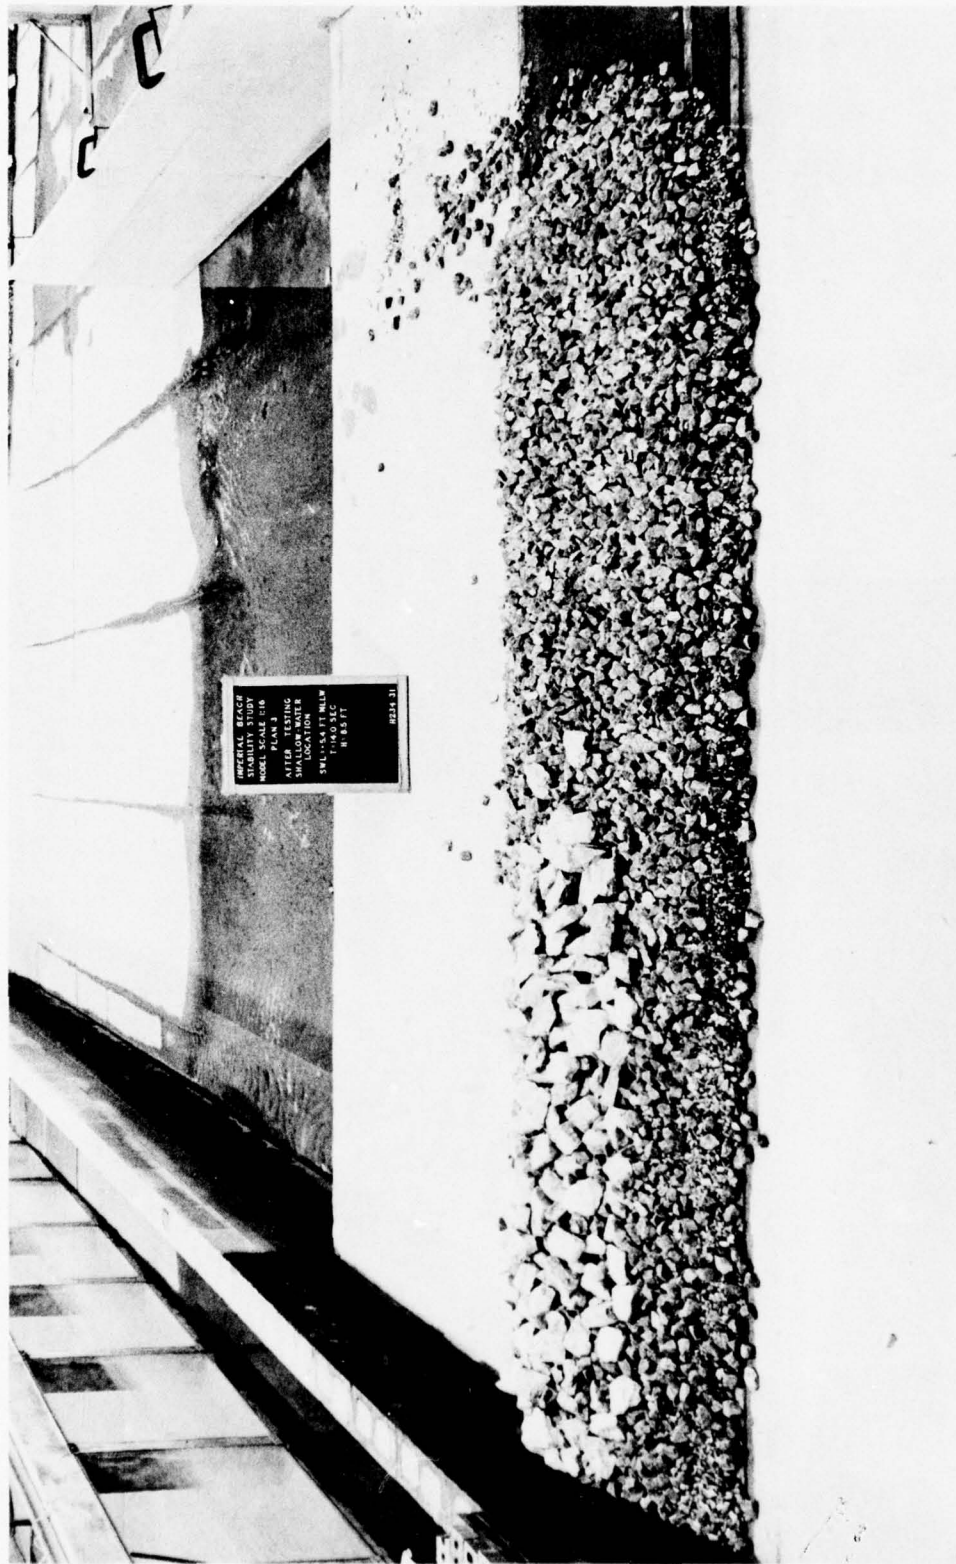
Photo 11. Sea-side view of Plan 3 in the shallow-water location after 2.0 hr of 14.0-sec, 8.5-ft waves at an swl of +5.4 ft mllw

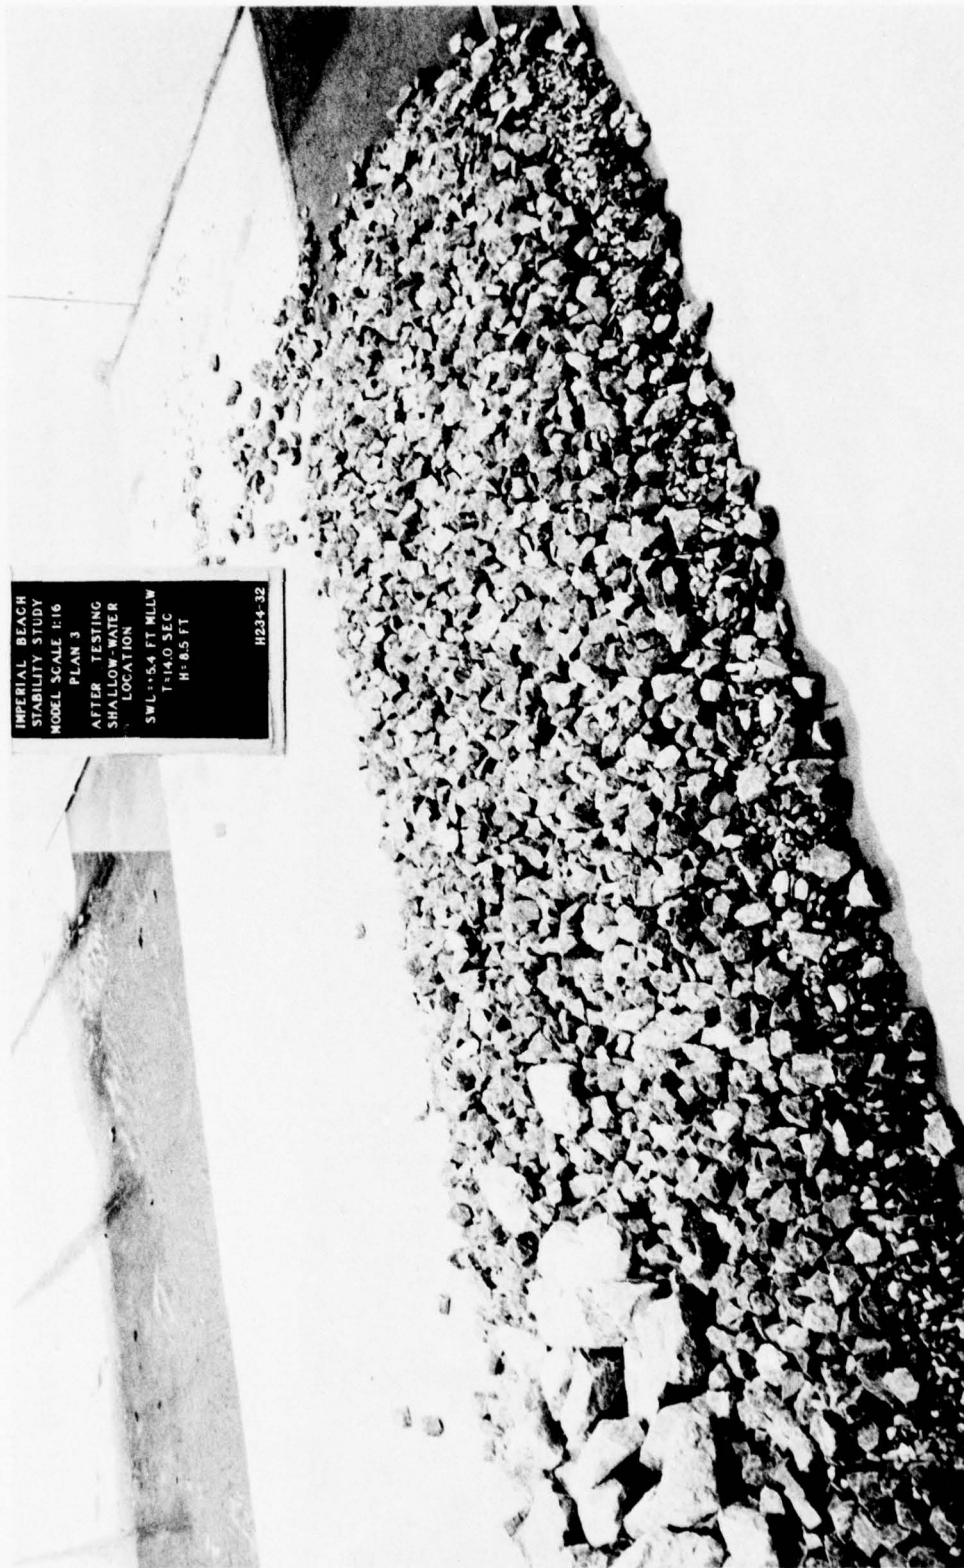
Photo 12. Sea-side view of low-sill section of Plan 3 in the shallow-water location after 2.0 hr of 14.0-sec, 8.5-ft waves at an swl of +5.4 ft mllw

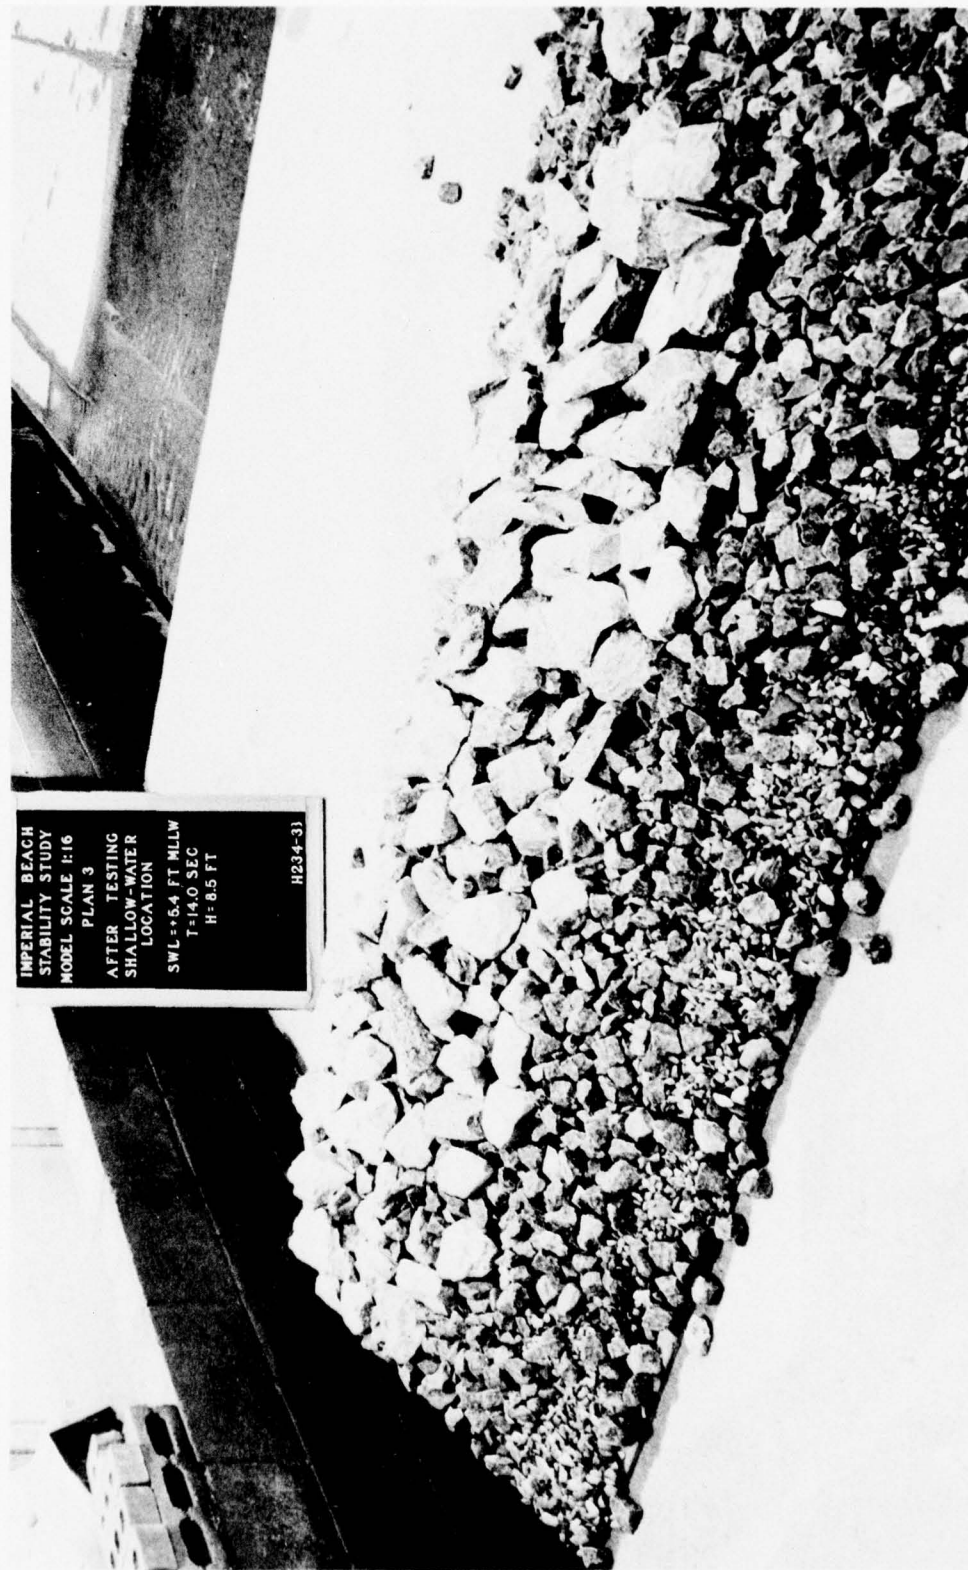
Photo 13. Sea-side view of high-sill section of Plan 3 in the shallow-water location after 2.0 hr of 14.0-sec, 8.5-ft waves at an swl of +5.4 ft mllw

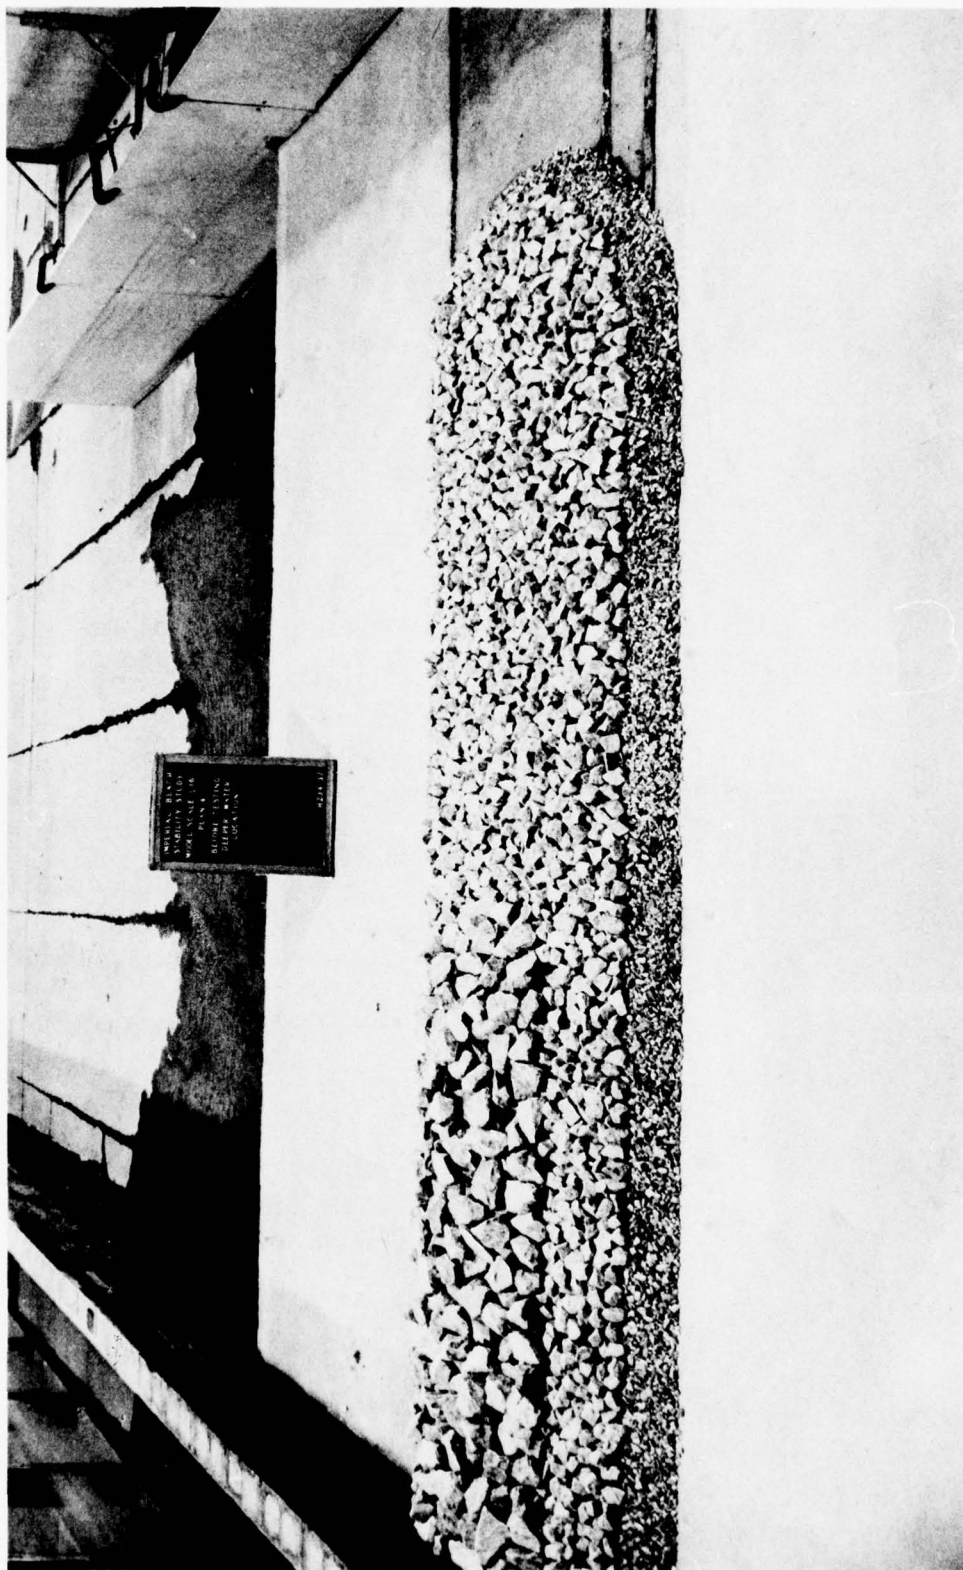
Photo 14. Sea-side view of Plan 4 before wave attack

15. Plan 4 (Plate 4 and Photo 14) was constructed in the deeper water location to high- and low-sill elevations of +6.0 ft and -3.0 ft mllw, respectively. The high sill was armored with 5.0-ton stone and the low sill used 1750-lb stone. The 5.0-ton and 1750-lb stone were built to slopes of 1V on 2H and 1V on 1.5H, respectively. Attack of 14.0-sec, 8.3-ft waves at an swl of 0.0 ft mllw for 1.5 hr produced only minor damage (Photo 15); however, test conditions were changed to 14.0-sec, 12.1-ft waves at an swl of +5.4 ft mllw and 2.0 hr of wave attack produced extensive damage to both the low- and high-sill sections of the structure (Photo 16).

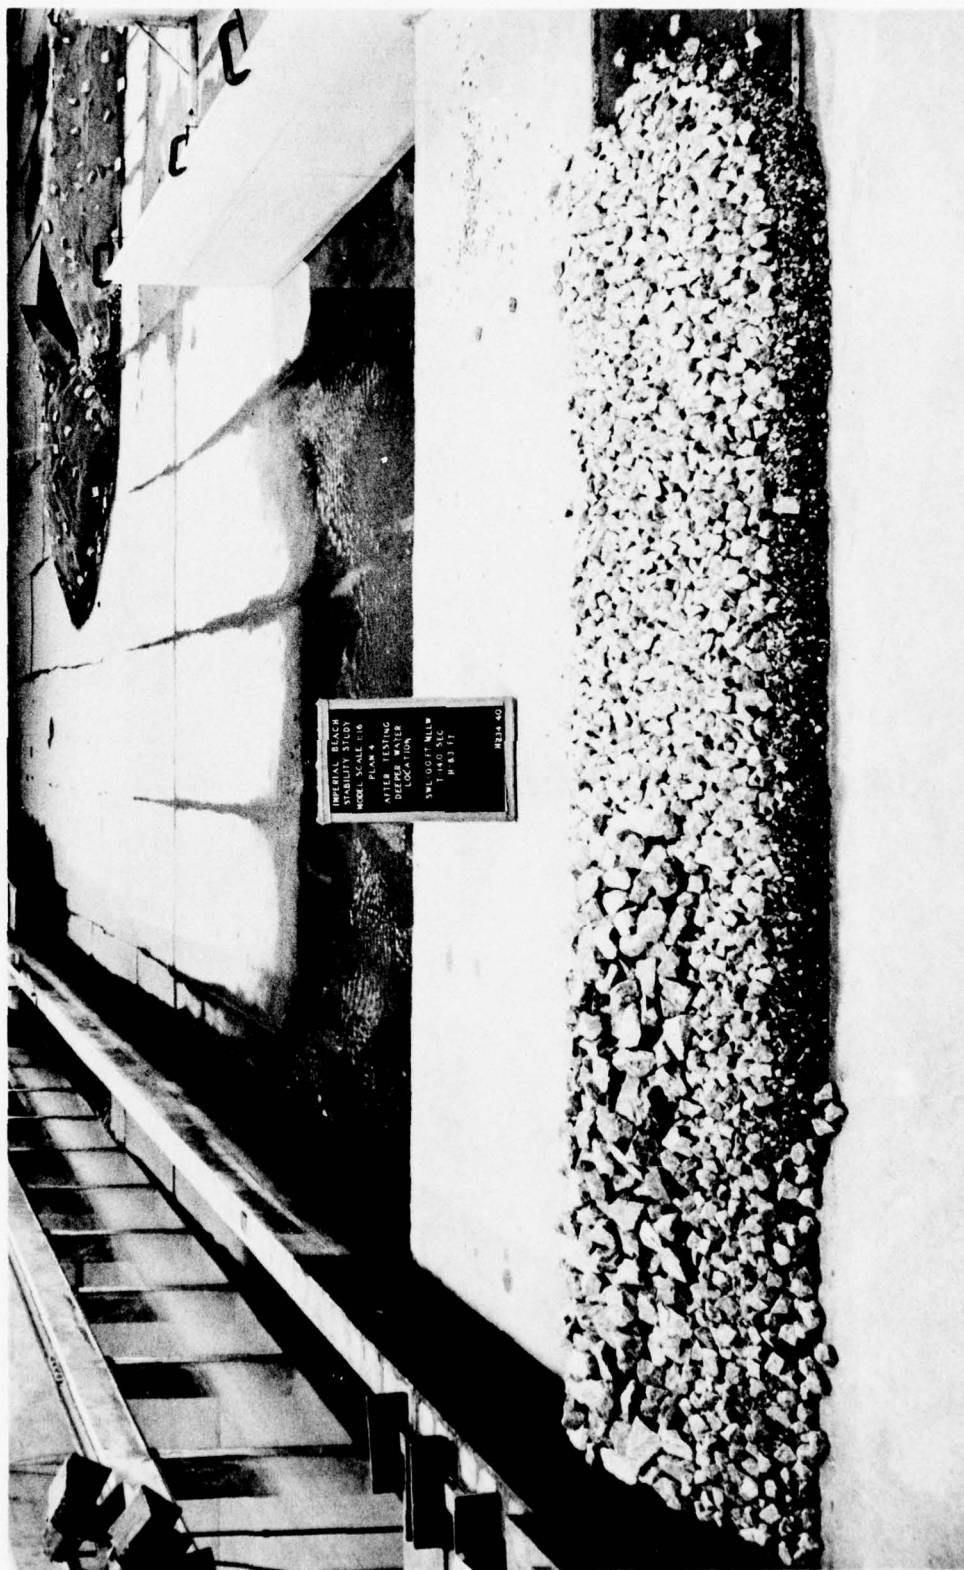
Photo 15. Sea-side view of Plan 4 in the deeper water location after 1.5 hr of 14.0-sec, 8.3-ft waves at an swl of 0.0 ft mllw
